RE: RCRA Facility Assessment Report (RFA)
American Standard, Inc., Louisville, Kentucky
EPA I.D. No. KYD 006 375 489

Recommendation Summary
RCRA Facility Assessment (RFA) Report

American Standard, Incorporated
Louisville, Kentucky
EPA I.D. No. KYD 006 375 489

Prepared by the Kentucky Division of Waste Management
Hazardous Waste Branch
Geoffrey Young

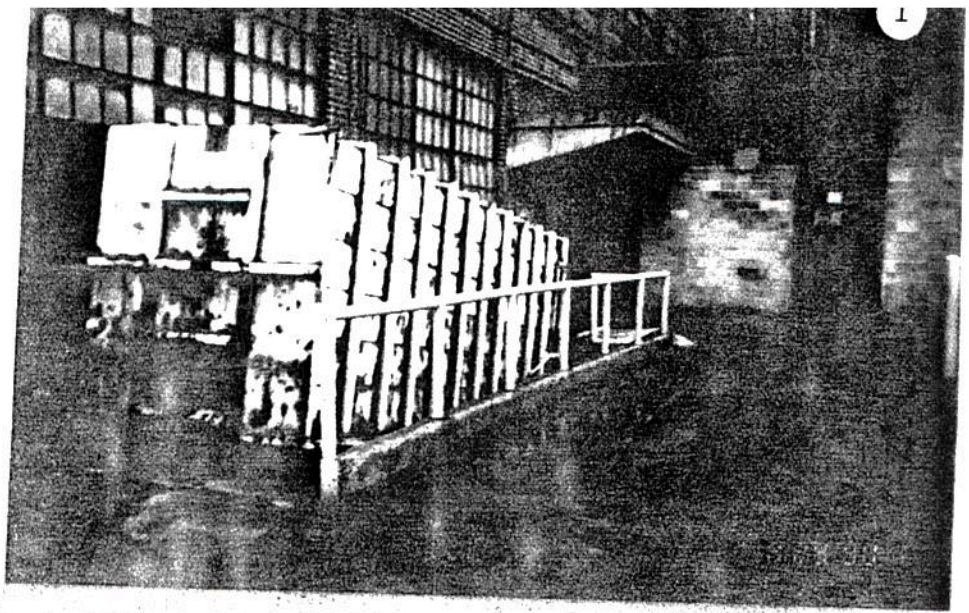
Trash Dumpster near facility offices.

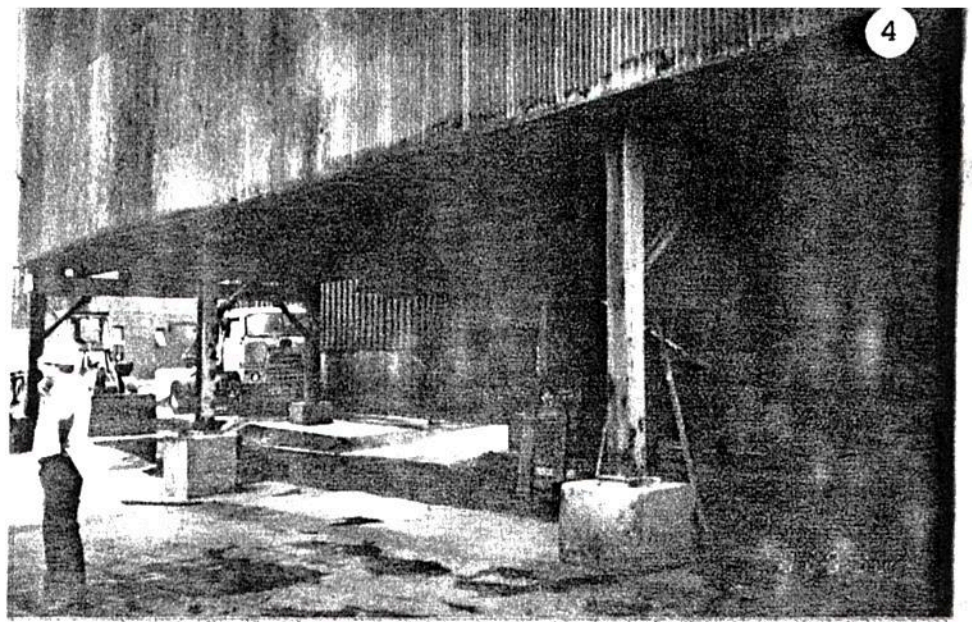
Loading Area Under Cupola Baghouse.

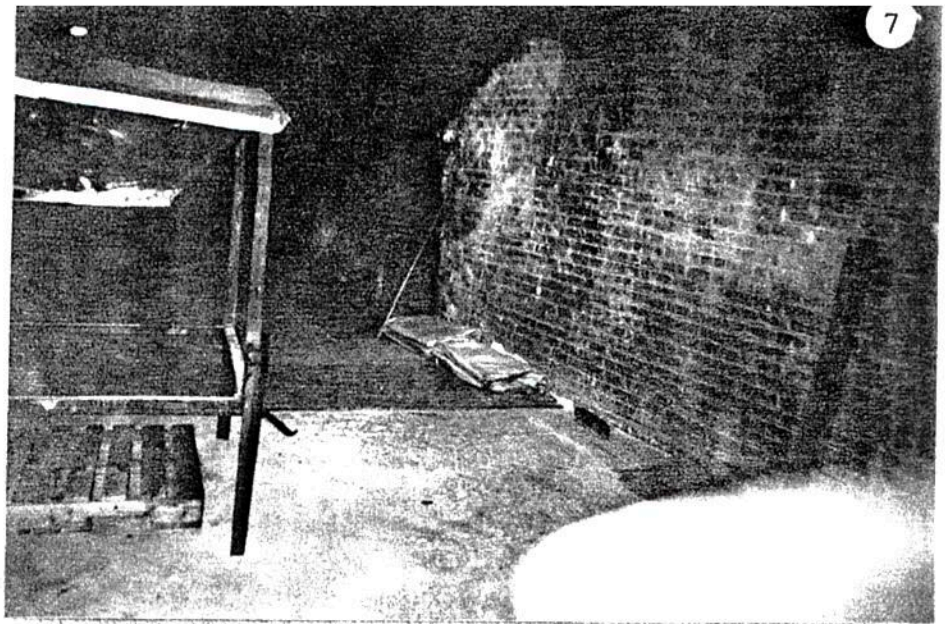
Temporary Waste Staging Area inside

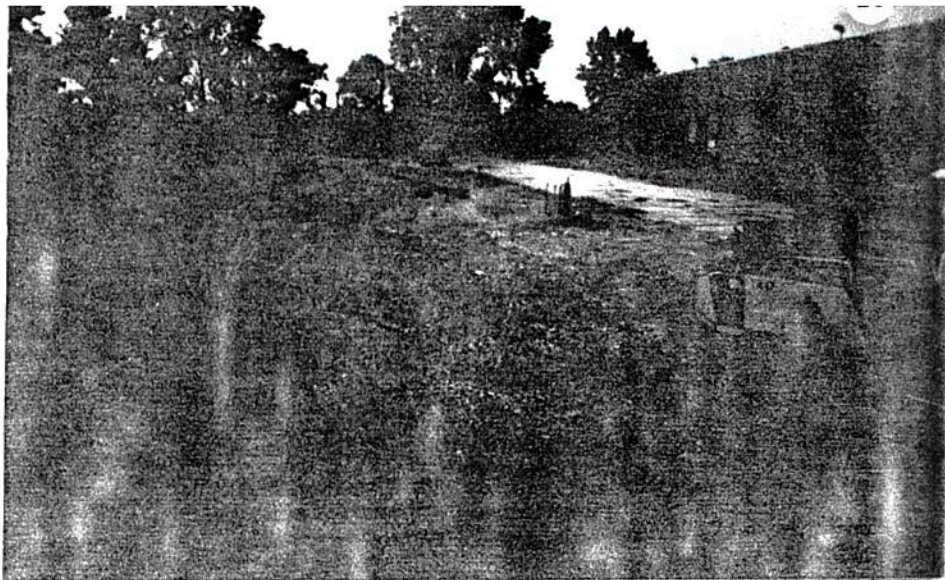
Soil sampling should be performed to determine if hazardous materials were released to the soil. Sampling should focus on the darkened areas. Constituents tested for should include the hazardous organic compounds which have been used at the facility in the past, PCBs, lead, cadmium, and chromium. If hazardous constituents are found, American Standard should be required to address this SWMU in a RCRA Facility Investigation (RFI).

Former Container Storage Area, SE of

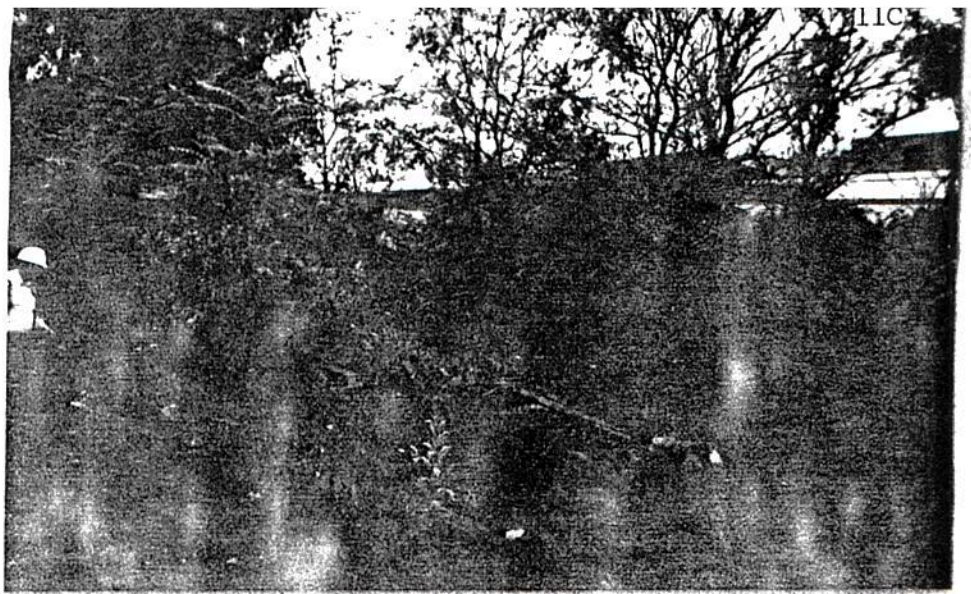
In the foreground of Photo #11A, a buried concrete structure is shown, which may represent the site where trash used to be burned (Ref. 3).

There is no evidence that the landfill was constructed with a liner either below or above the wastes. Because the site is essentially level, most of the rainwater falling on it probably leached downward through the waste and into the groundwater. If hazardous wastes were deposited in the unit, leaching and subsequent release of hazardous constituents to the environment are probable.

Inactive Landfill.

A phased sampling and analytical approach is recommended. The purpose of the first phase would be to determine whether the unit contains hazardous constituents. Random soil testing, at a range of depths, could provide information which would guide any subsequent phases of the investigation. Testing should be performed for at least the following constituents: lead, cadmium, chromium, PCBs, and the organic hazardous compounds which have been used at the facility in the past. If hazardous constituents are found, American Standard should be required to address this SWMU in an RFI.

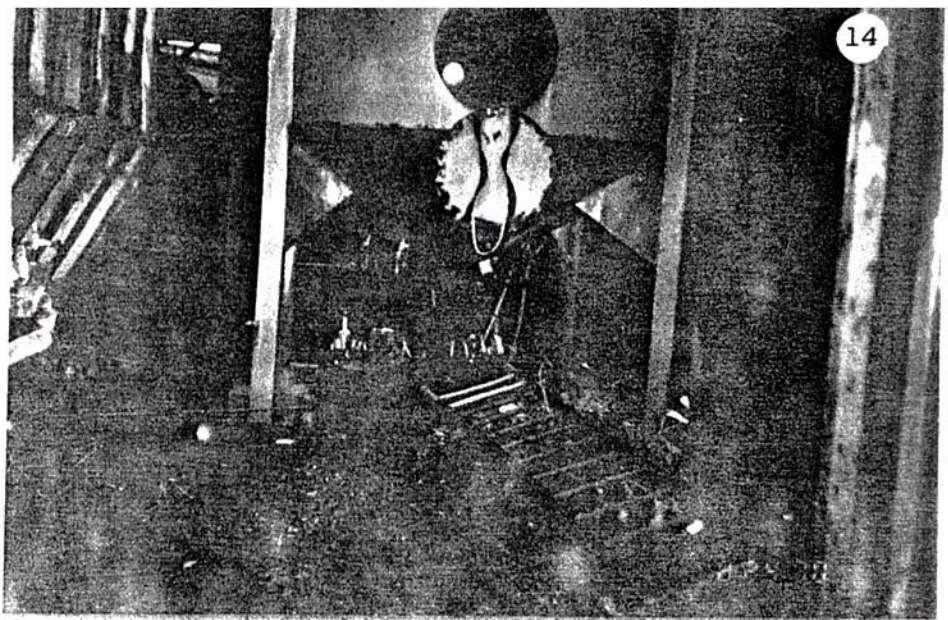
According to file information and facility personnel, there have been no releases
from this unit. The concrete diked area contains debris, equipment, and waste
material which facility personnel believe to be non-hazardous. If hazardous
material had been released from the tank, it would probably have been retained by
the concrete base and dike.

Although the probability of future releases of hazardous constituents from the tank
and dike system is low, only testing and analysis of the waste material within the
dike could determine whether hazardous constituents are present and whether
cleanup activities would be necessary.

Basecoat Tank and Dike outside Bldg. 57.

A wipe test should be performed on the inner surface of the bottom of the tank to
ascertain whether all of the D008 waste has been removed. The waste materials
deposited throughout the diked area should be sampled and analyzed for lead and
cadmium. If hazardous constituents are found, the waste should be removed down to
the bare concrete surfaces. The surfaces should then be tested again to ensure that
cleanup efforts have been successful.
